Inspection Report

PROPERTY INSPECTION REPORT

Concerning: 6643 Autumn Sunset Lane, Spring, TX 77379

07/27/2011

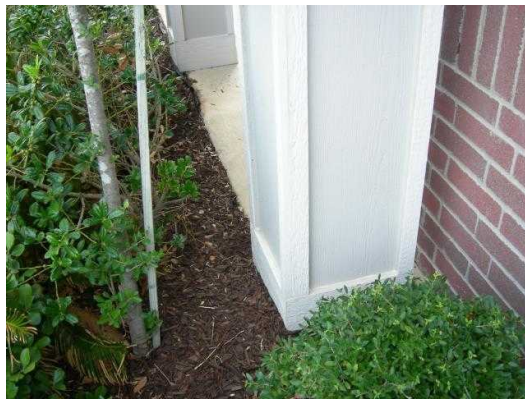
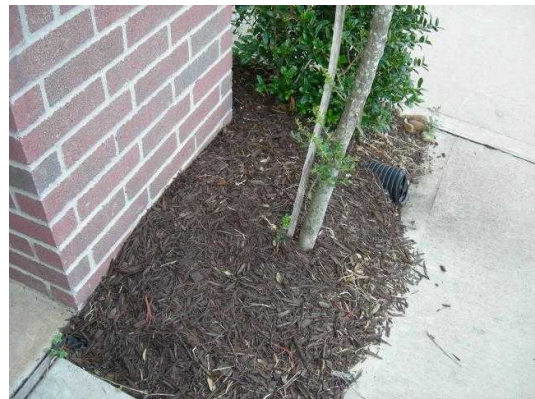
One or more areas around the foundation has high soil that may allow water/insects into the home (soil grade should typically be four to six inches below the top edge of foundation with positive slop away from the foundation for proper drainage).

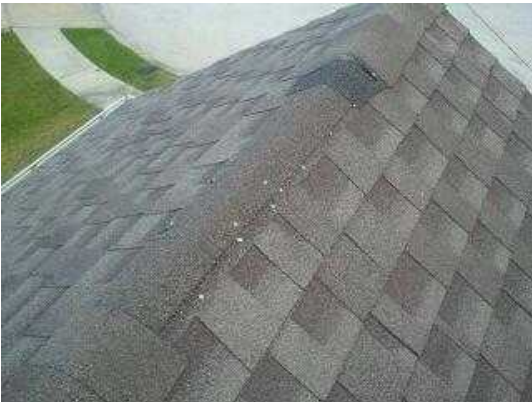
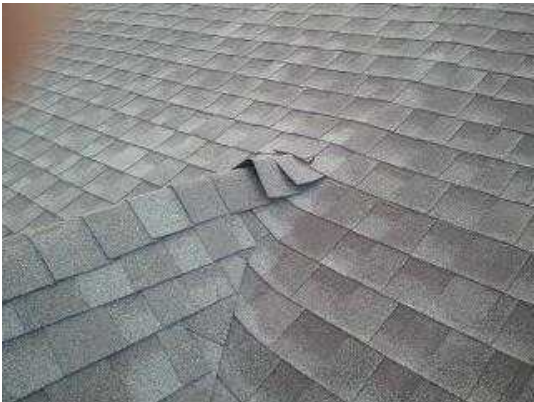
Some of the ridge shingles are missing on the right front side of the roof; recommend review for repairs by a qualified roofing contractor.

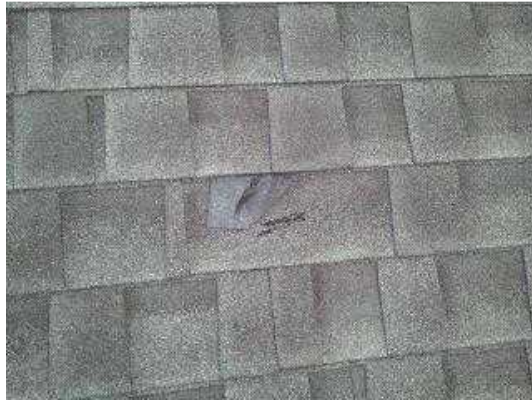
Some of the roof shingles are damaged at various locations on the room; recommend review for repairs by a qualified roofing contractor.

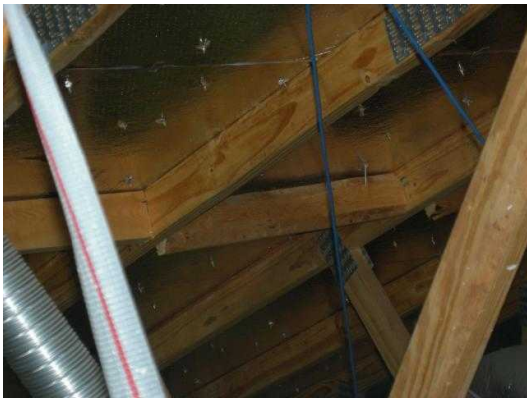
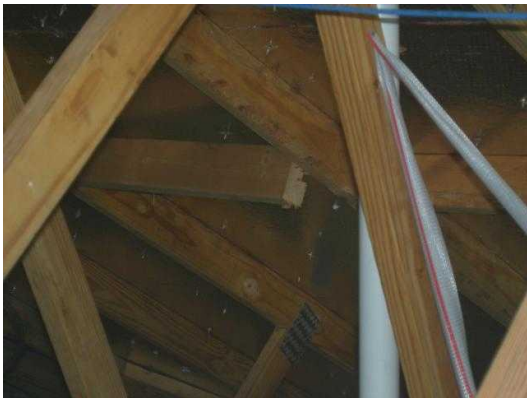
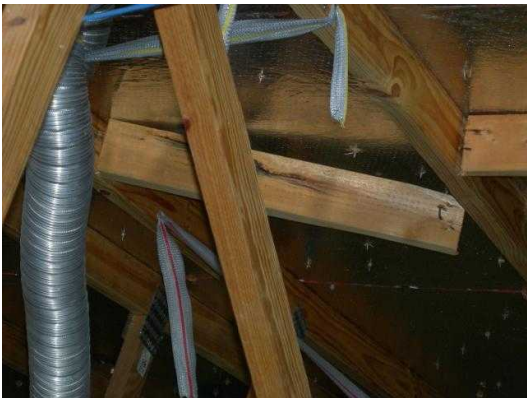
Issues:
Some of the bracing between the trusses is not secured properly; recommend repairs.

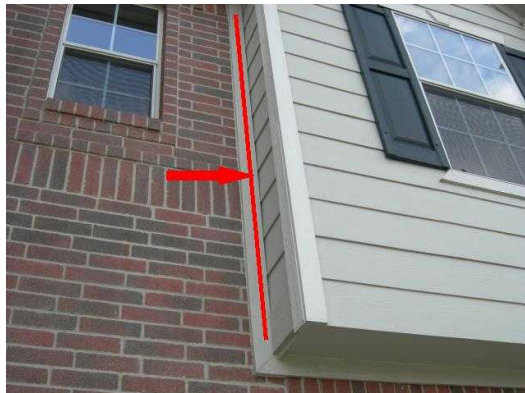
It is recommend to caulk the openings between the lap siding and the trim to prevent moisture entry.

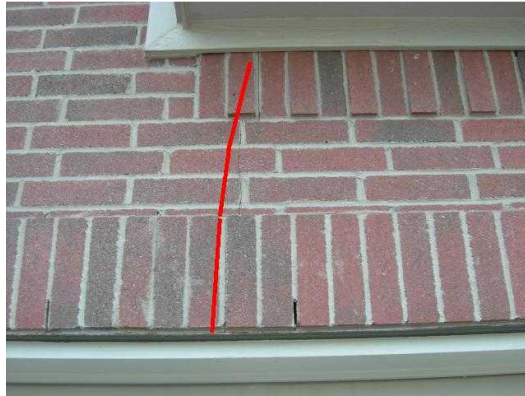
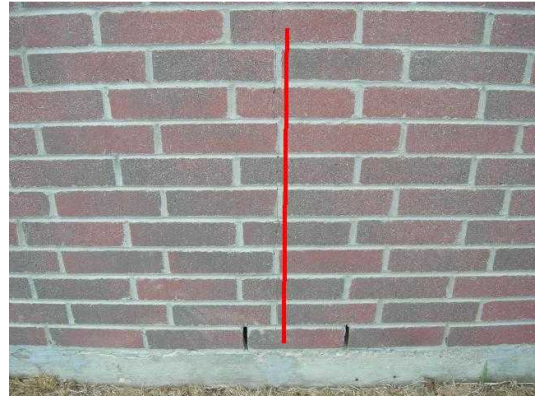
Slight stress cracks observed in the brick veneer wall on the left front side under the porch window, right front side of the home above the garage door, and right side of the home. This is an indication that previous deflection or thermo expansion has occurred at this location. Inspector is unable to determine when this occurred or if additional cracking is likely; recommend re-pointing (repairing) mortar to prevent moisture intrusion.

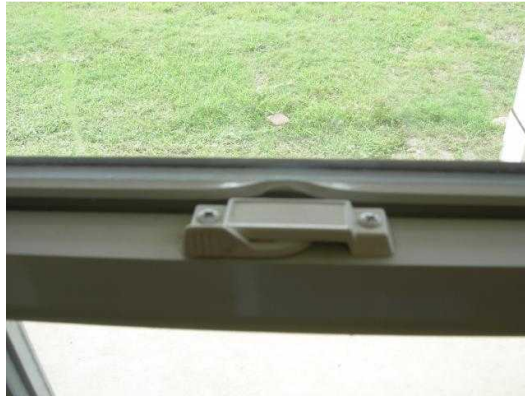
The window spring for the window on the right rear wall is disconnected or broken; recommend repairs to restore proper operation.

The bottom portion of the window frame by the window latch is bent.

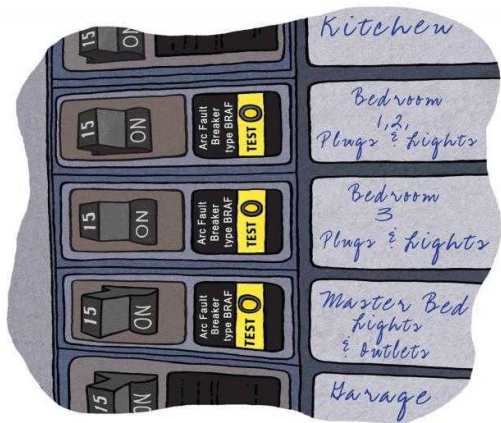
Some of the electrical panel screws are missing. We recommend securing the panel cover with the appropriate type screws, to help assure safety and serviceability. Pointed screws, which can pierce the outer insulation causing electrocution, is a safety hazard.

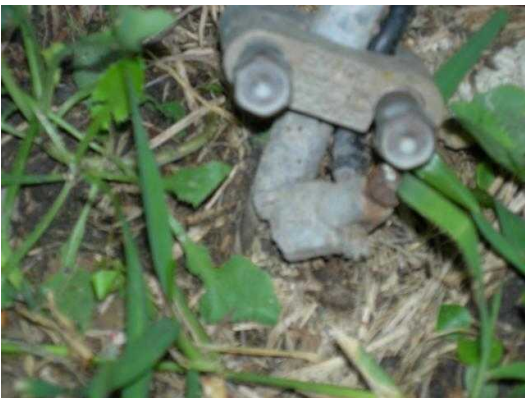
The ground wire is disconnected to the exterior grounding rod clamp; recommend re-securing for proper grounding.

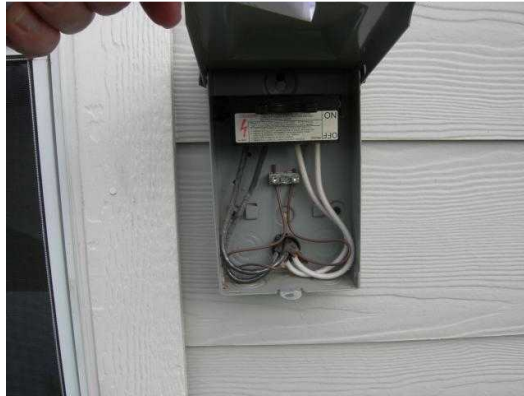
The interior dead front cover is missing for the A/C disconnect; recommend replacement by a licensed electrician for safety.

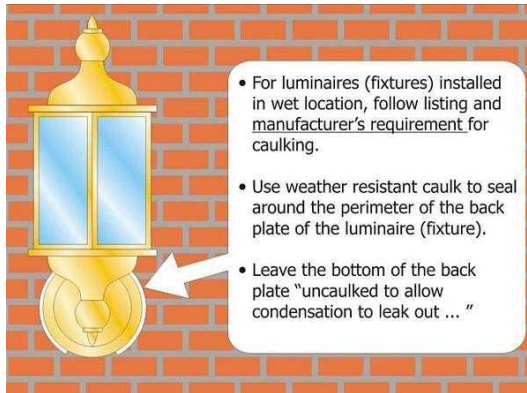
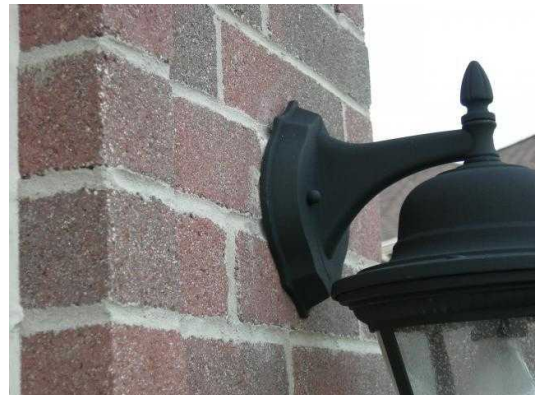
Recommend sealing around all exterior light fixtures to prevent moisture from entering into the electrical junction box.

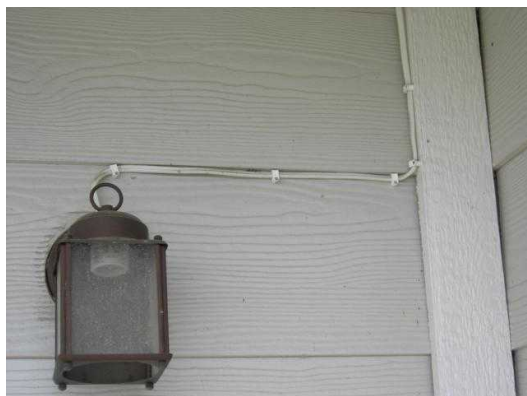
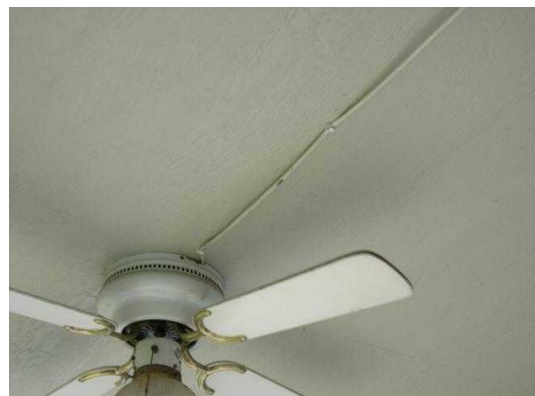
Extension cord used improperly as permanent wiring for the patio ceiling fan. Extension cords should not be used for permanent wiring due to fire safety concerns. It is unknown if this fan is rated for a damp location. Recommend installation of proper electrical wiring and receptacles to ensure safety by a licensed electrical contractor.

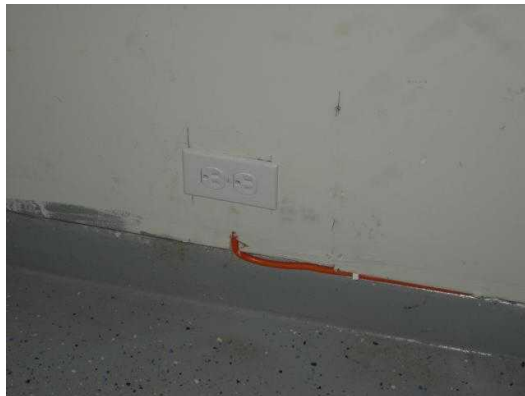
Extension cord used improperly as permanent wiring. Extension cords should not be used for permanent wiring due to fire safety concerns. Recommend installation of proper electrical wiring and receptacles to ensure safety by a licensed electrical contractor.

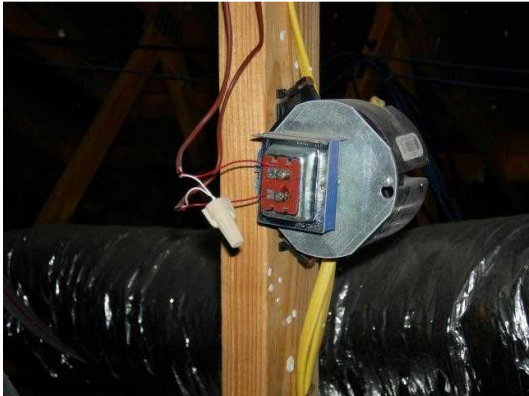
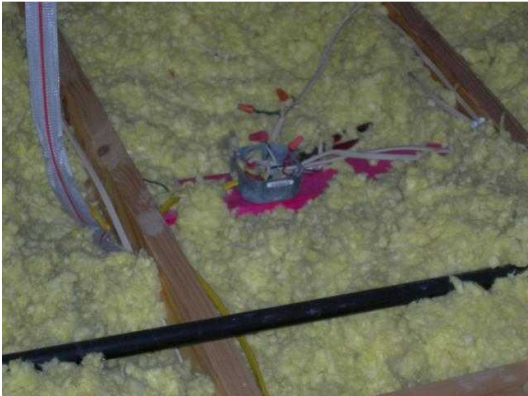
Open splices or bare wire observed on the left and back side of the upper attic, which is a "Safety Concern". Whenever an electric wire is cut and reconnected, the "splice" should be encased in a covered "junction box" to prevent shock or separation of the splice.

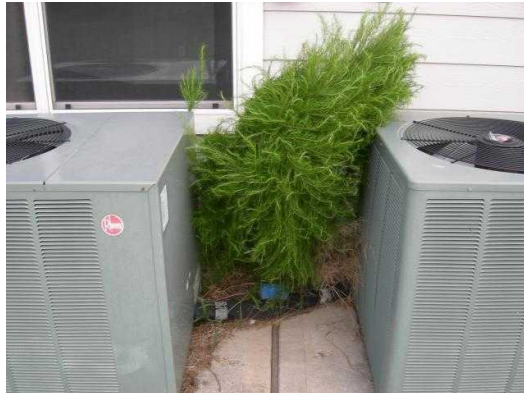
Plants/shrubs should be kept 18 inches from outside unit as not to interfere with the system; recommend trimming or removing.

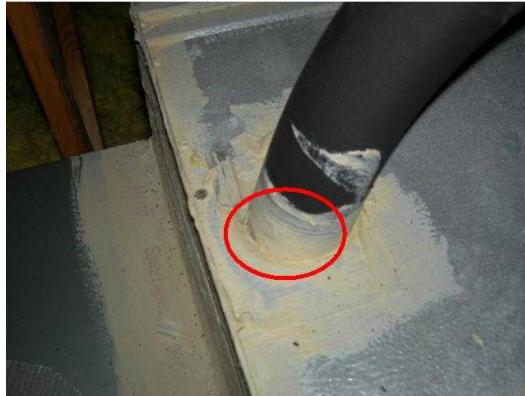
Recommend sealing gap around refrigerant line entrance to the upstairs evaporator coil to prevent loss of conditioned air.

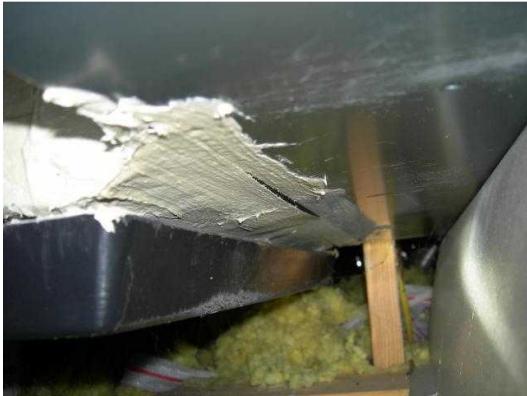
Portions of plenum between the downstairs (heater/evaporator coil or evaporator coil/supply plenum) are not secured properly, which is allowing conditioned air to escape; recommend complete review and repairs by a licensed HVAC contractor to improve energy efficiency.

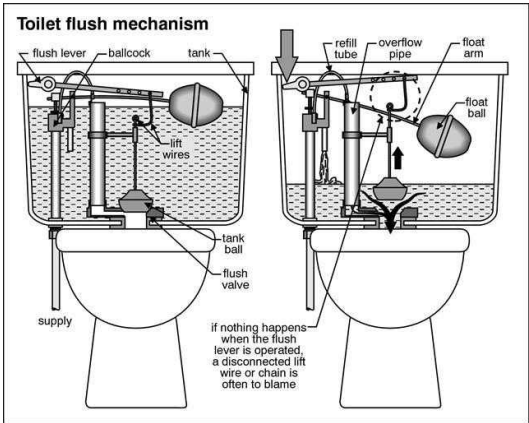
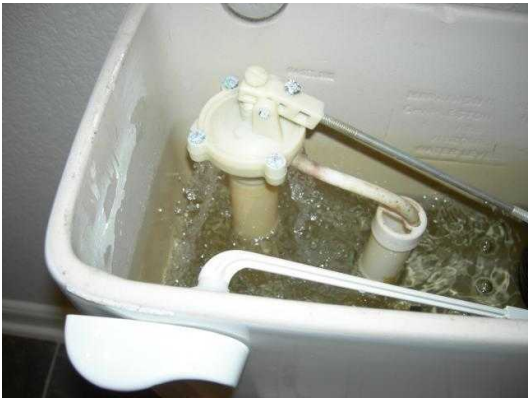
The toilet ball cock valve, located inside the toilet tank, is leaking around the top of the valve; recommend replacing by a licensed plumbing contractor.

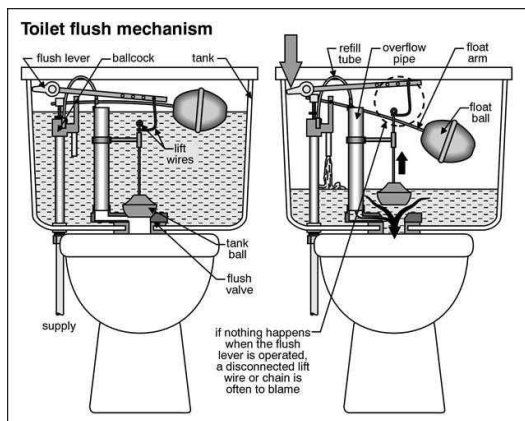
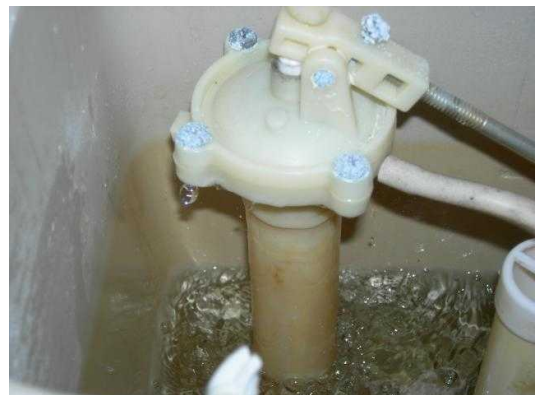
The toilet ball cock valve, located inside the toilet tank, is leaking around the top of the valve; recommend replacing by a licensed plumbing contractor.

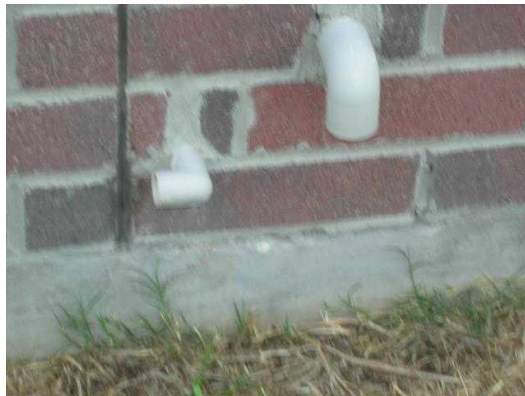
The drain termination for the temperature pressure relief valve should be pointing downward and the exposed plastic pipe should be painted to prevent deterioration from the sun; recommend repairs.

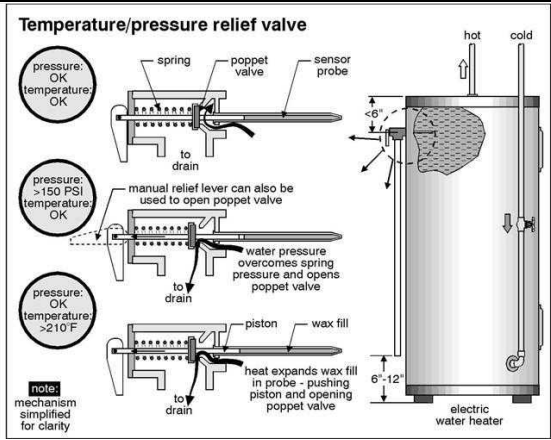
The temperature and pressure relief valve was not operated due to the age of the unit or the lever would not operate easily. In most cases, the valve will not reset under these conditions, which would allow water to run continuously through the drain pipe. The safety relief valve should be operated at least once a year by the water heater owner to insure waterways are clear. The safety relief valve should be inspected by a licensed plumber every 3 years. If this has not been done, it is recommended to replace this relief valve.
